Why does my Camaro or Firebird shred belts?

1993-94 Chevrolet Camaro built prior to Vin breakpoint 2G1FP22P2R2158372

1993-94 Pontiac Firebird built prior to Vin breakpoint 2G2FV22P7R2223329

5.7L V8 (VIN P – RPO LT1)

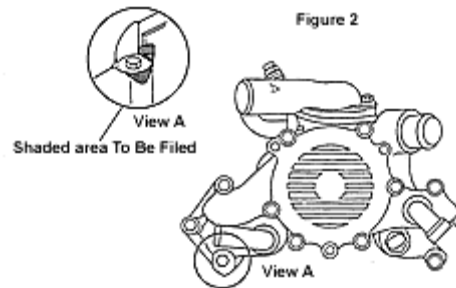
There is excessive shredding of the inner edge of the serpentine belt.

Excessive aluminum flash material below the lower left coolant pump bolt contacting the inner edge of the serpentine belt. See figure A below.

To fix this belt shredding once and for all, locate the excessive flash material (lower left bolt of coolant pump) and break it off with a set of pliers and smooth with a small file. Note: Do not remove any coolant pump bolts as this will disturb the gasket may create a coolant leak.
