## Certain Coolant pump pulleys Cause for Concern

2003-2005 super duty pickups and Excursions  
2004-2005 E series vans

**Engine:** 6.0L Turbo Diesel (only)

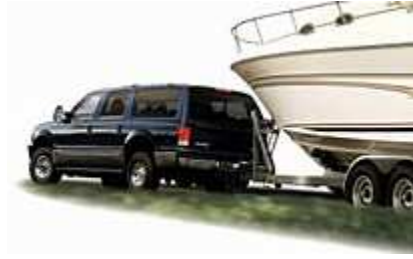
**Condition:** Shredded, frayed and or broken serpentine belt

**Cause:** Coolant pump pulley roughness/ damage.

**Correction:** Replace the coolant pump pulley with updated pulley and replace serpentine belt with new design (more durable) serpentine belt. See part numbers below.
