# -Service Bulletin-

Re: 1996 - 2000 Chrysler 3.0L V6 Field Fix Kit

Voyager/Caravan/Lebaron/Daytona/Spirit/Dynasty/Monaco/Acclaim/Sundance/Premier

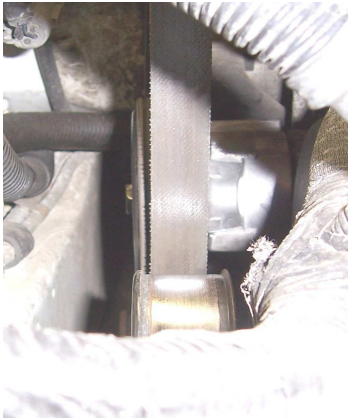
### OE System

Notice the misalignment!

This picture shows the OE system. Notice how the system is causing the belt to become "misaligned". When this smooth tensioner pulley gets wet, the belt tends to slip off leaving the customer stranded.

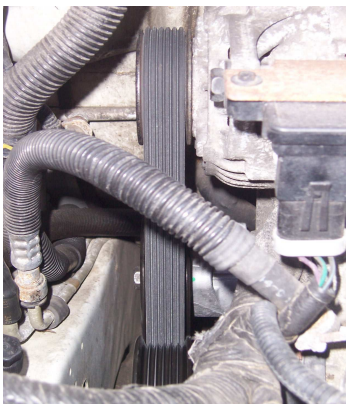
Unique double ribbed belt  
installed on the 3.0L V6.

This picture shows our system with the "unique" double ribbed belt design and grooved idler. Notice how "aligned" the belt is. This grooved system will not allow the belt to slip off any of the pulleys.

Our field fix kit consists of a new tensioner (with a grooved pulley), a grooved idler and a "unique" double sided belt. This belt is unique because it has grooves on both sides and is the key to why our system performs so well. This type of belt design is highly recommended for serpentine belt drives that are sensitive to misalignment and poor tracking.
