*Counterfeit Tensioner Analysis  
for “06D 109 243B”  
VW/Audi Timing belt tensioner*

February 2013

## *Competitive Tensioner Analysis - Background*

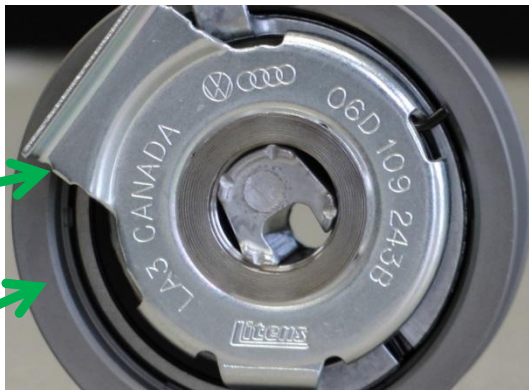
06D 109 243B

Side of index tab not straight trim cut

Grey Pulley

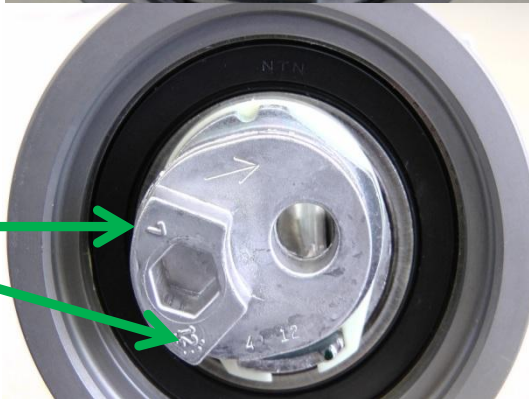
Raised Cavity Identifiers

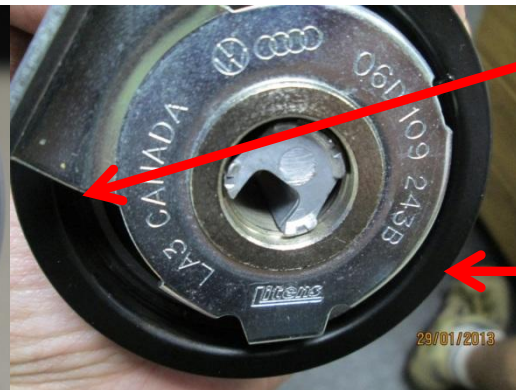
06D 109 243B

Side of index tab straight trim cut

Black Pulley

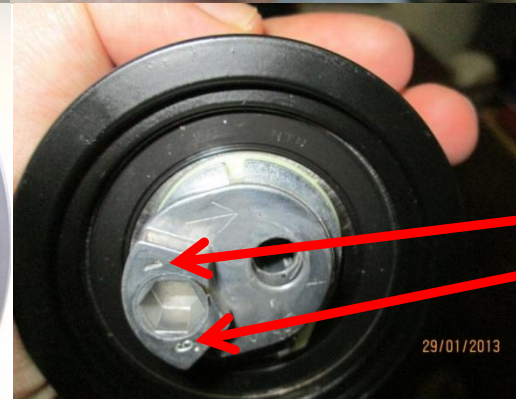
Recessed Cavity Identifiers
